**Flood Control Project Maintenance
Levee Inspections**
LMA District Cover Sheet
Spring 2018 Levee Inspection Results

Reclamation District No. 2031 Elliot

Waterway			Bank	Unit Miles
Unit No. 01 Stanislaus River			Left	7.07
	Spring (March - May)	Summer (June - August)	(September - November) Fall	Winter (December - February)
Unit Maintenance Rating (Fall Only)				
Date of Inspection	5/16/2018 - 5/16/2018			
DWR Inspector	Sterling York			
Accompanied By	Arvid Carlson RD2031

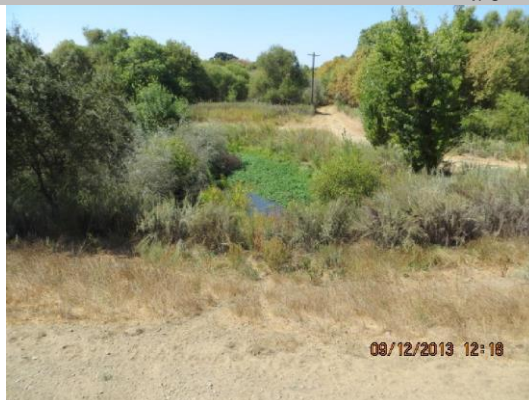
Photo 2 of 3 : UCIP_SP_2018_20704_34825.jpg

Pond at outlet on WS toe.

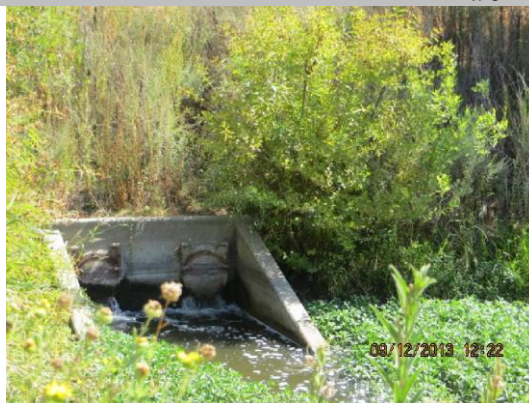
Photo 3 of 3 : UCIP_SP_2018_20704_34824.jpg

Flap gate at Concrete outlet on WS toe.

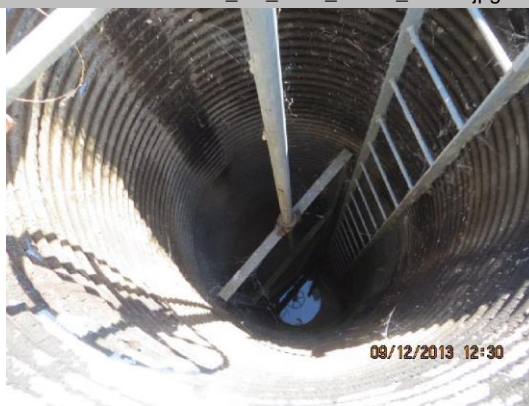
Photo 1 of 3 : UCIP_SP_2018_52626_34834.jpg

Slide gate in CMP riser on WS slope.

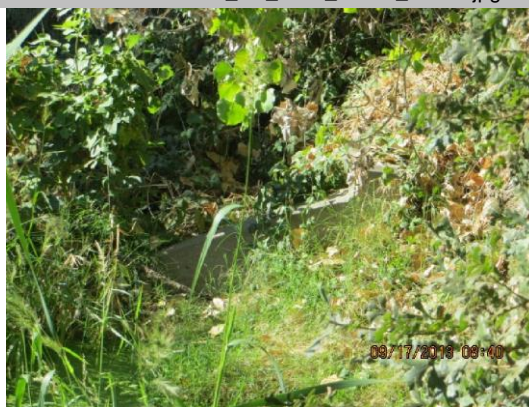
Photo 2 of 3 : UCIP_SP_2018_52626_34833.jpg

Concrete headwall on LS toe at edge of pond.

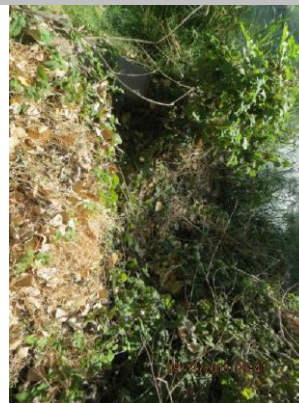
Photo 3 of 3 : UCIP_SP_2018_52626_34832.jpg

Concrete headwall on LS toe at edge of pond.

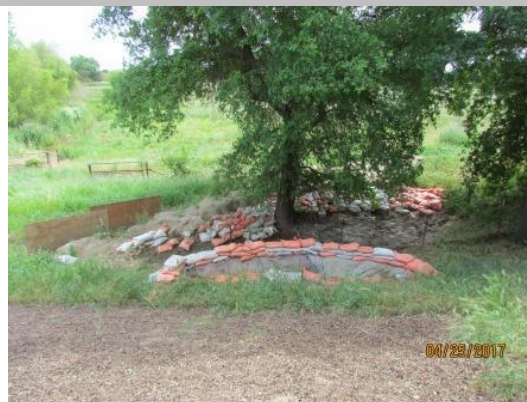
Photo 1 of 1 : SP_2018_RD2031_308_22_20180515_00008.jpg

LM Start	0.33	Rating **	U	Issue No.	22
LM End	0.33	Issue Type +	Ob	Location *	LS
Category	Earthen Levee			GPS Latitude/Longitude	
				Start	End
Item	Seepage / Sandboils			37.657380 °	37.657380 °
				-121.235006 °	-121.235006 °
DWR ID	DWR_RD2031_02_s_2017_22				
Comment Code					
Inspector Comment

View of the sack rings at the levee toe.

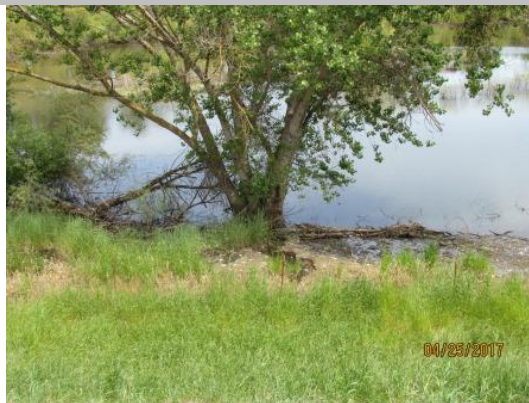
Photo 1 of 1 : SP_2018_RD2031_308_24_20180515_00009.jpg

LM Start	0.75	Rating **	U	Issue No.	24
LM End	1.11	Issue Type +	Ob	Location *	LS
Category	Earthen Levee			GPS Latitude/Longitude	
				Start	End
Item	Seepage / Sandboils			37.653954 °	37.651915 °
				-121.229623 °	-121.223617 °
DWR ID	DWR_RD2031_02_s_2017_24				
Comment Code					
Inspector Comment

View of the seepage at the levee toe.

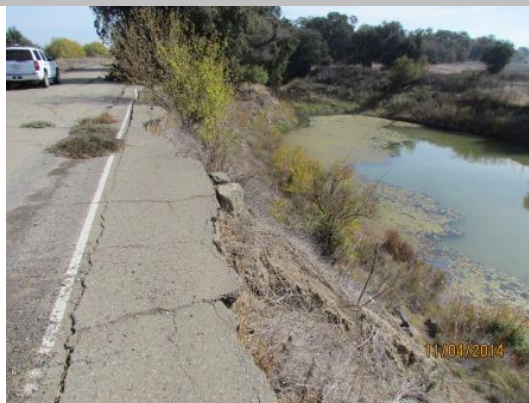
Photo 1 of 1 : SP_2018_RD2031_308_26_20180515_00010.jpg

LM Start	2.27	Rating **	U	Issue No.	26
LM End	2.28	Issue Type +	Ob	Location *	WS
Category	Earthen Levee			GPS Latitude/Longitude	
				Start	End
Item	Erosion / Bank Caving			37.640371 °	37.640340 °
				-121.219254 °	-121.218974 °
DWR ID	DWR_RD2031_02_f_2014_26				
Comment Code					
E1 : Note and monitor erosion site.					
Inspector Comment

View of the caving bank on the waterside facing upstream.

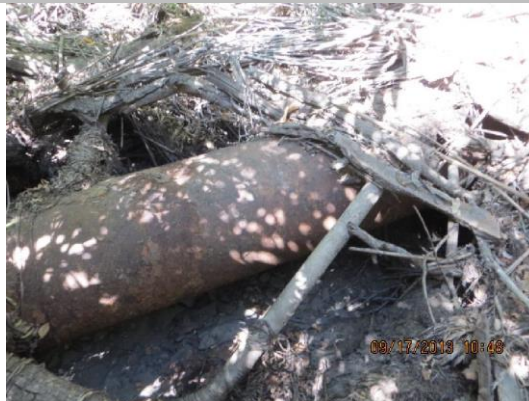
Photo 1 of 3 : UCIP_SP_2018_20713_34838.jpg

Comment Code					
Inspector Comment					
FS_ID:20713 DS_ID:20490 EP_NO: 11758 Repair Type: Non-Urgent Crossing Status: Found UCIP Comments: Pipe rusted through and failing at WS toe. Good indicator of internal condition of pipe. Good candidate for video inspection. FIELD_STRUCT_DESC: 24-inch corrugated metal gravity drainage pipe through the levee, 17 feet below the crown. 20-inch steel pipe and 1.25-inch galvanized conduit sleeved through the 24-inch pipe. Annular space pressure grouted. Slide gate in a 48-inch corrugated metal pipe (CMP) riser on the landside (LS) slope. 36-inch concrete standpipe at the LS toe with pump on a 48-inch steel standpipe. (20-inch and 1.5-inch pipes installed under Permit No. 11758, 1976 - Faith Ranch). [Additional Reference(s): DWR Levee Log, 2005. USACE San Joaquin O&M Manual 4, June 1968, (HLM 2.75)]. FS Date: 9/17/2013

Pipe visible on LS toe.

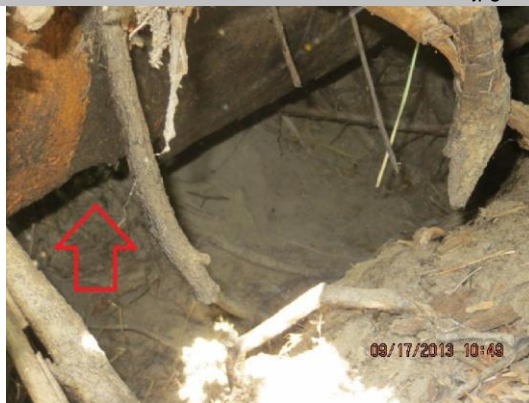
Photo 2 of 3 : UCIP_SP_2018_20713_34837.jpg

Flow line of pipe completely rusted through at LS toe.

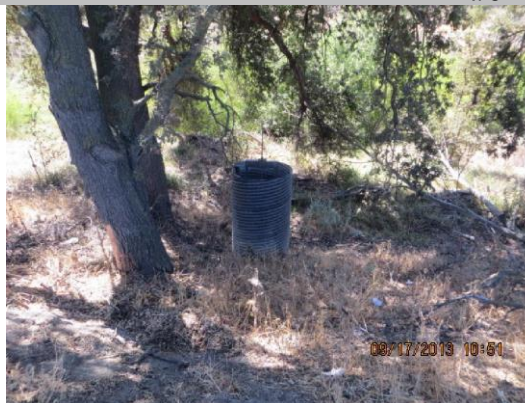
Photo 3 of 3 : UCIP_SP_2018_20713_34836.jpg

Comment Code						
Inspector Comment						
FS_ID:20713 DS_ID:20490 EP_NO: 11758 Repair Type: Non-Urgent Crossing Status: Found UCIP Comments: Pipe rusted through and failing at WS toe. Good indicator of internal condition of pipe. Good candidate for video inspection. FIELD_STRUCT_DESC: 24-inch corrugated metal gravity drainage pipe through the levee, 17 feet below the crown. 20-inch steel pipe and 1.25-inch galvanized conduit sleeved through the 24-inch pipe. Annular space pressure grouted. Slide gate in a 48-inch corrugated metal pipe (CMP) riser on the landside (LS) slope. 36-inch concrete standpipe at the LS toe with pump on a 48-inch steel standpipe. (20-inch and 1.5-inch pipes installed under Permit No. 11758, 1976 - Faith Ranch). [Additional Reference(s): DWR Levee Log, 2005. USACE San Joaquin O&M Manual 4, June 1968, (HLM 2.75)]. FS Date: 9/17/2013

Slide gate in 48-inch CMP riser on WS slope.

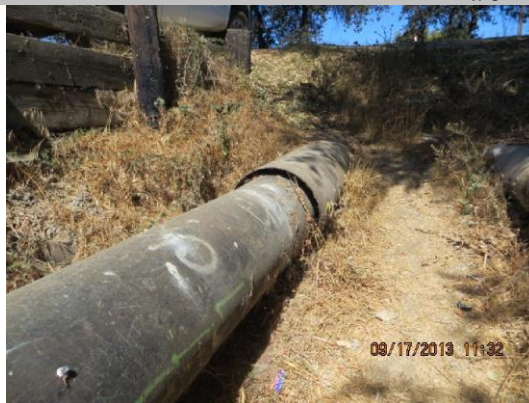
Photo 1 of 3 : UCIP_SP_2018_20719_34860.jpg

LM Start	3.21	Rating **	M	Issue No.	971	
LM End	3.21	Issue Type +	En	Location *		
Category	Supplemental			GPS Latitude/Longitude		
				Start		End
Item	DWR UCIP Field Study			37.638185 °	37.638185 °	
				-121.202906 °	-121.202906 °	
DWR ID						
Comment Code						
Inspector Comment						
FS_ID:20719 DS_ID:20492 EP_NO: N/A Repair Type: Non-Urgent Crossing Status: Found UCIP Comments: Annular space between 20-inch and 24-inch pipe not grouted. FIELD_STRUCT_DESC: 24-inch steel irrigation pipe through the levee, 8 feet below the crown. 20-inch steel pipe sleeved through the 24-inch pipe. Pump on pile structure in river. 4-foot by 11-foot concrete distribution box on the landside (LS) toe. 2-inch electrical conduit at the same location. [Additional Reference(s): DWR Levee Log, 2005. USACE San Joaquin O&M Manual 4, June 1968, (HLM 3.24)]. FS Date: 9/17/2013

24-inch with 20-inch sleeved through it.

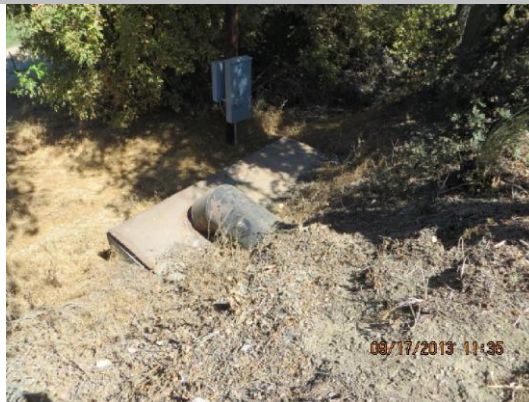
Photo 2 of 3 : UCIP_SP_2018_20719_34859.jpg

Concrete distribution box on LS slope.

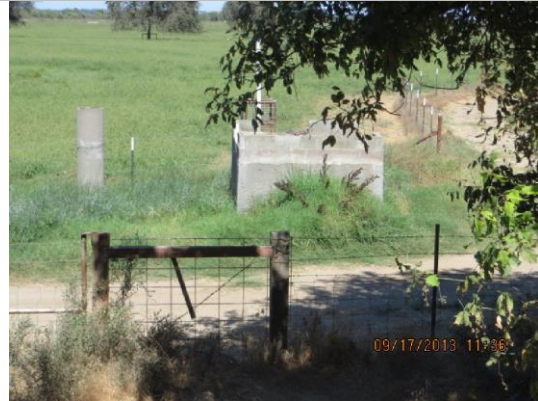
Photo 3 of 3 : UCIP_SP_2018_20719_34858.jpg

Concrete distribution box off LS toe.

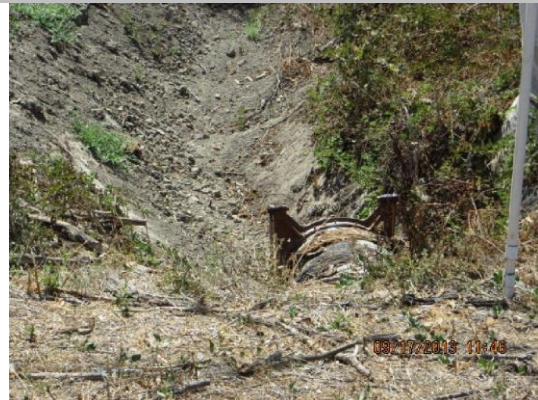
Photo 1 of 3 : UCIP_SP_2018_20723_34882.jpg

LM Start	3.76	Rating **	A/W	Issue No.	972
LM End	3.76	Issue Type +	Ma	Location *	
Category	Supplemental			GPS Latitude/Longitude	
				Start	End
Item	DWR UCIP LMA Responsibility			37.638063 °	37.638063 °
				-121.192917 °	-121.192917 °
DWR ID					
Comment Code					
Inspector Comment					
FS_ID:20723					
DS_ID:20507					
EP_NO: N/A					
Repair Type: No Action Needed					
Crossing Status: Found					
UCIP Comments:					
FIELD_STRUCT_DESC: 5-foot by 5-foot reinforced concrete box drainage culvert semi-through the levee, 11 feet below the crown. 30-inch pipe runs through the culvert. Drop inlet next to concrete headwall on the landside (LS) toe. [Additional Reference(s): USACE San Joaquin O&M Manual 4, June 1968, (HLM 3.80)].					
FS Date: 9/17/2013

Flap gate on CMP pipe at WS toe.

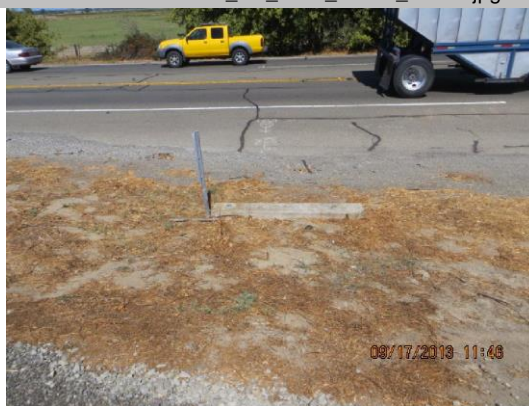
Photo 2 of 3 : UCIP_SP_2018_20723_34881.jpg

Concrete headwall on LS toe.

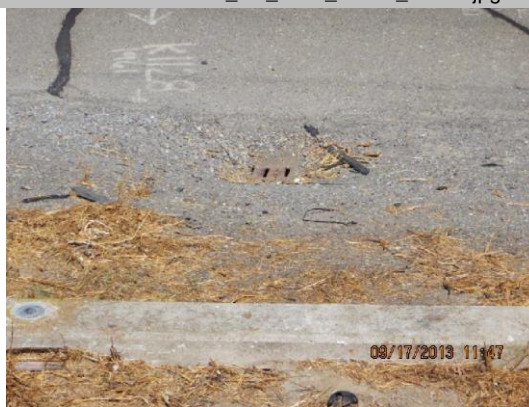
Photo 3 of 3 : UCIP_SP_2018_20723_34880.jpg

Drop inlet on LS toe.

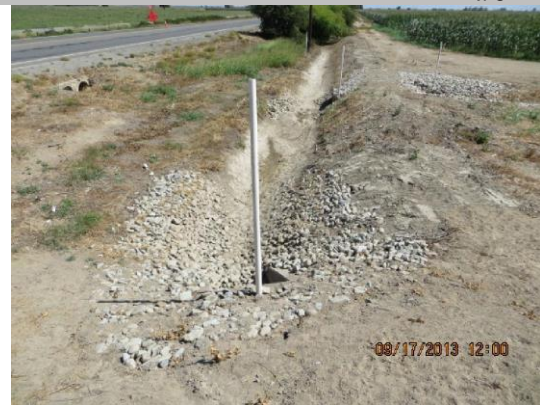
Photo 1 of 3 : UCIP_SP_2018_51374_34886.jpg

Comment Code					
Inspector Comment					
FS_ID:51374					
DS_ID:20496					
EP_NO: N/A					
Repair Type: No Action Needed					
Crossing Status: Found					
UCIP Comments: 11/16/2016 Crossing has been downgraded from Urgent to No Action Needed debris has been cleared from both WS and LS. (O. Magana - DWR UCIP)09/17/2013 Minor debris blocking closure of flapgate on WS toe. (W. Wylie - DWR UCIP)					
FIELD_STRUCT_DESC: 24-inch corrugated metal drainage pipe through the levee, 11 feet below the crown. Concrete U-shaped headwalls on each end. Flap gate on the waterside (WS) end.					
[Additional Reference(s): DWR Levee Log, 2005. USACE San Joaquin O&M Manual 4, June 1968, (HLM 3.88), Drawing No. 07-04-1666, Sheets 1666/23 and 1666/53, (Station 2+38S.T)].					
FS Date: 11/16/2016

Concrete headwall on LS toe.

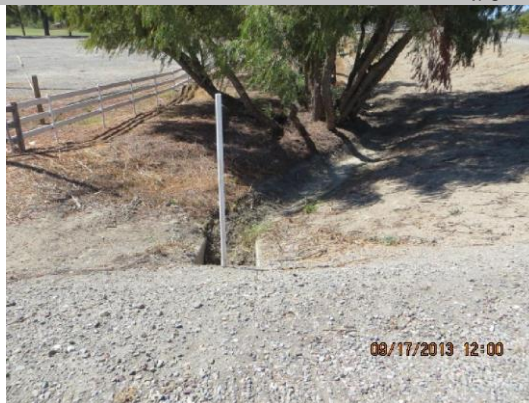
Photo 2 of 3 : UCIP_SP_2018_51374_34885.jpg

Concrete headwall on WS toe.

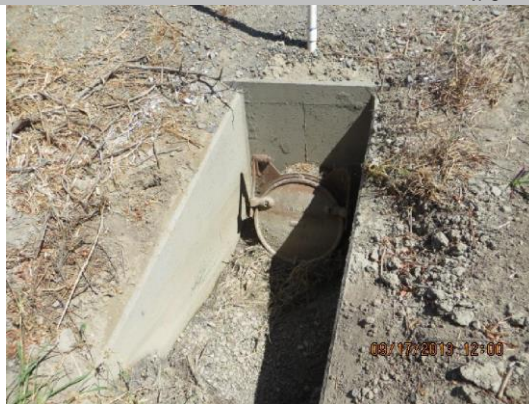
Photo 3 of 3 : UCIP_SP_2018_51374_34884.jpg

Flapgate on WS toe.

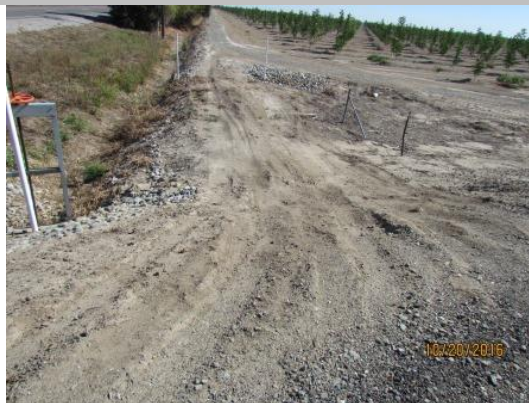
Photo 1 of 1 : SP_2018_RD2031_308_17_20180515_00006.jpg

LM Start	3.84	Rating **	A	Issue No.	17
LM End	3.84	Issue Type +	Ma	Location *	CR
Category	Earthen Levee			GPS Latitude/Longitude	
				Start	End
Item	Slope Stability			37.637916 °	37.637916 °
				-121.191595 °	-121.191595 °
DWR ID	DWR_RD2031_02_f_2016_17				
Comment Code					
S3 : Repair the levee slope damaged by vehicle traffic and prevent access where possible.					
Inspector Comment					
The slope does not show any signs of separation, loss of soil, or instability, Spring 2018.

View of the tire tracks on the levee slope.

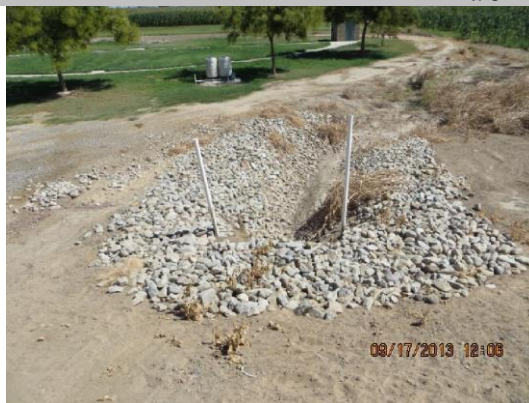
Photo 1 of 3 : UCIP_SP_2018_20728_34895.jpg

LM Start	4.16	Rating **	A/W	Issue No.	975
LM End	4.16	Issue Type +	Ma	Location *	
Category	Supplemental			GPS Latitude/Longitude	
				Start	End
Item	DWR UCIP LMA Responsibility			37.633376 °	37.633376 °
				-121.190765 °	-121.190765 °
DWR ID					
Comment Code					
Inspector Comment					
FS_ID:20728 DS_ID:20497 EP_NO: N/A Repair Type: No Action Needed Crossing Status: Found UCIP Comments: FIELD_STRUCT_DESC: 24-inch corrugated metal drainage pipe through the levee, 9.6 feet below the crown. Concrete U-shaped headwalls on each end. Flap gate on the waterside (WS) end. Flashboards in slots on the landside (LS) headwall. [Additional Reference(s): DWR Levee Log, 2005. USACE San Joaquin O&M Manual 4, June 1968, (HLM 4.20)]. FS Date: 9/17/2013

Concrete headwall at ditch on LS toe.

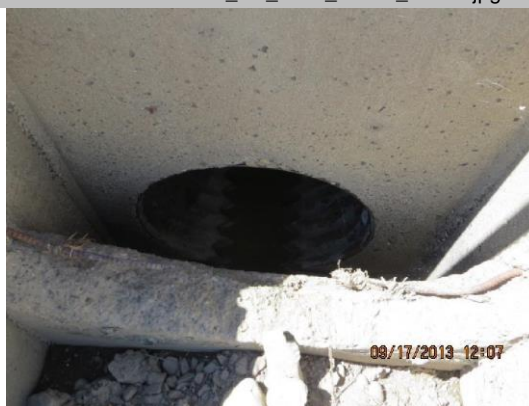
Photo 2 of 3 : UCIP_SP_2018_20728_34894.jpg

Concrete headwall on LS toe.

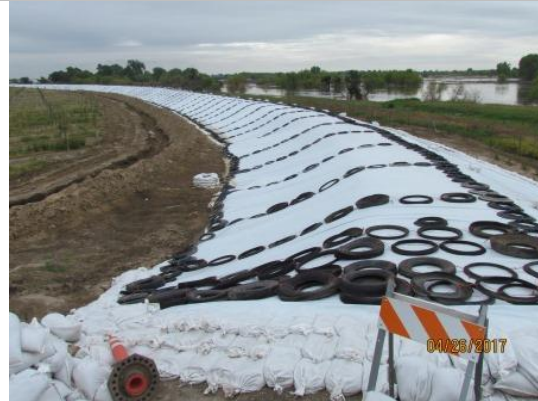
Photo 1 of 1 : SP_2018_RD2031_308_28_20180515_00013.jpg

LM Start	4.22	Rating **	U	Issue No.	28
LM End	4.51	Issue Type +	Ob	Location *	LS
Category	Earthen Levee			GPS Latitude/Longitude	
				Start	End
Item	Seepage / Sandboils			37.632448 °	37.630914 °
				-121.190601 °	-121.185914 °
DWR ID	DWR_RD2031_02_s_2017_28				
Comment Code					
Inspector Comment					
Raincoat applied to levee section and ditch cut about 12 feet from levee toe to intercept seepage.

View of the raincoat and seepage catch ditch near the levee.

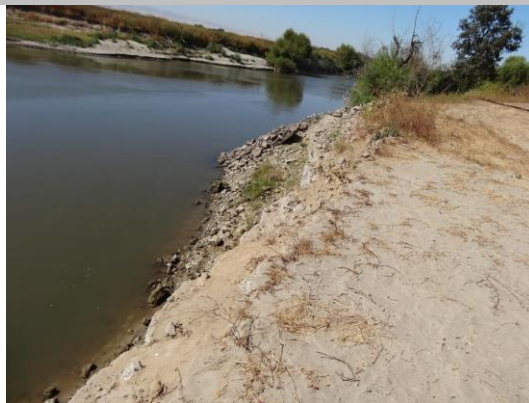
Photo 2 of 4 : SP_2018_RD2031_308_1_20180515_00002.jpg

Item	DWR Erosion Survey			37.631716 °	37.630765 °	
				-121.189370 °	-121.159189 °	
DWR ID	RD2031U02RM78.7					
Comment Code						
Inspector Comment						
10/04/2017: The erosion in the berm again was found further progressed toward levee toe. 07/08/2016: The erosion in the berm was found further progressed toward levee toe. 08/19/2015: No significant change observed. 07/17/2014: The erosion has slightly expanded toward levee toe at two pocket locations. 09/10/2013: The site has been visited. The erosion has expanded toward levee crest at two pocket locations. 07/18/2012: No significant change observed on the site. 08/18/2011: No significant change observed on the site. Dead trees and animal activities are visible. The closest point of the erosion site to the levee toe is about 100 ft. 10/19/2010: There is active scouring occurring on the bank due to the nature of the flow and the lack of armor protection. There is also a fallen log immediately downstream of where the erosion has occurred and is protruding outward, possibly creating an eddy and scouring the bank. With the remaining 100-foot wide berm, the levee prism is not yet affected. However, the bank will continue to degrade, and eventually intrude into the levee prism if no protection is put in place. Erosion site is recommended for annual assessment and monitoring during flood events. [2017 Site ID:RD2031U02RM78.7]

Looking downstream of the erosion site.

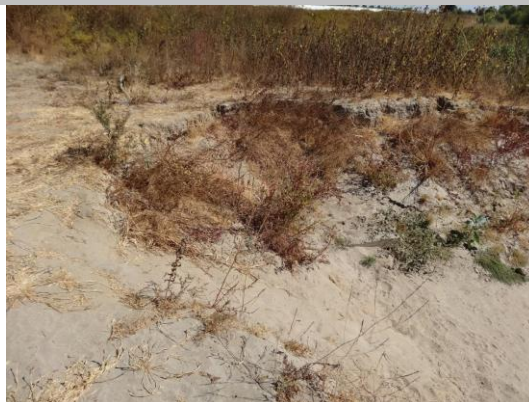
Photo 3 of 4 : SP_2018_RD2031_308_1_20180515_00003.jpg

Close view of the pocket erosion.

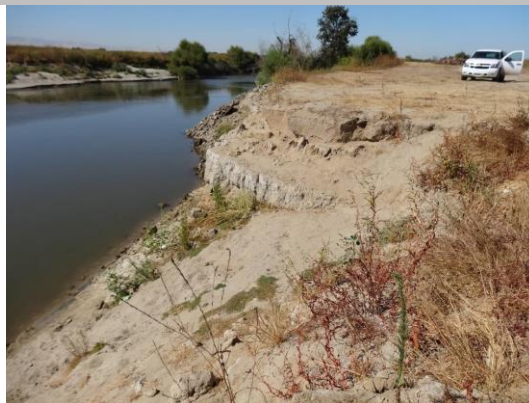
Photo 4 of 4 : SP_2018_RD2031_308_1_20180515_00004.jpg

Item	DWR Erosion Survey			37.631716 °		37.630765 °
				-121.189370 °		-121.159189 °
DWR ID	RD2031U02RM78.7					
Comment Code						
Inspector Comment						
10/04/2017: The erosion in the berm again was found further progressed toward levee toe.						
07/08/2016: The erosion in the berm was found further progressed toward levee toe.						
08/19/2015: No significant change observed.						
07/17/2014: The erosion has slightly expanded toward levee toe at two pocket locations.						
09/10/2013: The site has been visited. The erosion has expanded toward levee crest at two pocket locations.						
07/18/2012: No significant change observed on the site.						
08/18/2011: No significant change observed on the site. Dead trees and animal activities are visible. The closest point of the erosion site to the levee toe is about 100 ft.						
10/19/2010: There is active scouring occurring on the bank due to the nature of the flow and the lack of armor protection. There is also a fallen log immediately downstream of where the erosion has occurred and is protruding outward, possibly creating an eddy and scouring the bank. With the remaining 100-foot wide berm, the levee prism is not yet affected. However, the bank will continue to degrade, and eventually intrude into the levee prism if no protection is put in place. Erosion site is recommended for annual assessment and monitoring during flood events. [2017 Site ID:RD2031U02RM78.7]

Close view of the erosion.

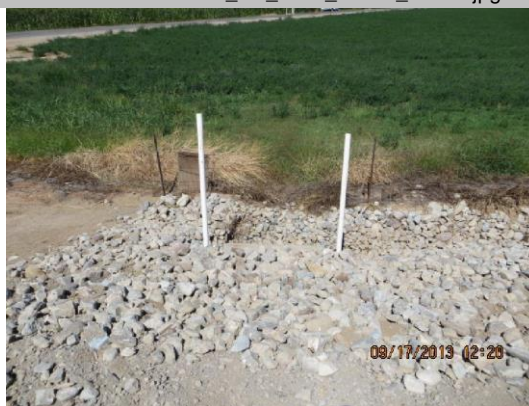
Photo 1 of 3 : UCIP_SP_2018_22872_39036.jpg

LM Start	4.70	Rating **	M	Issue No.	976
LM End	4.70	Issue Type +	En	Location *	
Category	Supplemental			GPS Latitude/Longitude	
				Start	End
Item	DWR UCIP Field Study			37.630815 °	37.630815 °
				-121.182416 °	-121.182416 °
DWR ID					
Comment Code					
Inspector Comment					
FS_ID:22872 DS_ID:24676 EP_NO: N/A Repair Type: Non-Urgent Crossing Status: Found UCIP Comments: No permit identified for this crossing. FIELD_STRUCT_DESC: 16-inch polyvinyl chloride (PVC) irrigation pipe through the levee, 6 feet below the crown. Headwall on the landside (LS) toe. FS Date: 9/17/2013

Concrete headwall at outlet on LS toe.

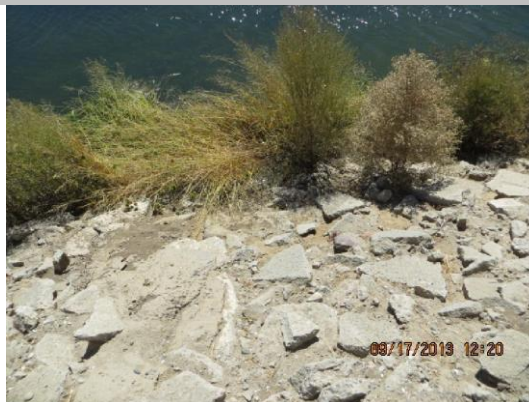
Photo 2 of 3 : UCIP_SP_2018_22872_39035.jpg

LM Start	4.70	Rating **	M	Issue No.	976 (cont)
LM End	4.70	Issue Type +	En	Location *

Concrete debris placed over pipe location on WS shoulder.

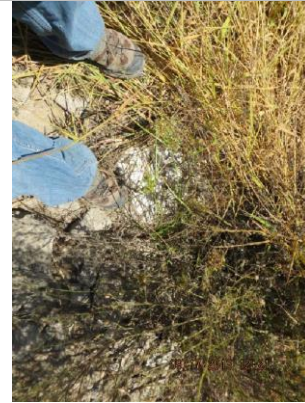
Photo 3 of 3 : UCIP_SP_2018_22872_39034.jpg

LM Start	4.70	Rating **	M	Issue No.	976 (cont)	
LM End	4.70	Issue Type +	En	Location *		
Category	Supplemental			GPS Latitude/Longitude		
				Start		End
Item	DWR UCIP Field Study			37.630815 °		37.630815 °
				-121.182416 °		-121.182416 °
DWR ID						
Comment Code						
Inspector Comment						
FS_ID:22872 DS_ID:24676 EP_NO: N/A Repair Type: Non-Urgent Crossing Status: Found UCIP Comments: No permit identified for this crossing. FIELD_STRUCT_DESC: 16-inch polyvinyl chloride (PVC) irrigation pipe through the levee, 6 feet below the crown. Headwall on the landside (LS) toe. FS Date: 9/17/2013

PVC pipe partially visible on WS toe.

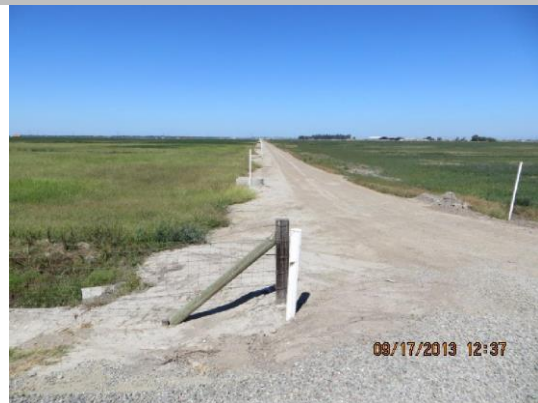
Photo 1 of 2 : UCIP_SP_2018_22873_39038.jpg

LM Start	5.63	Rating **	M	Issue No.	977
LM End	5.63	Issue Type +	En	Location *	
Category	Supplemental			GPS Latitude/Longitude	
				Start	End
Item	DWR UCIP Field Study			37.630779 °	37.630779 °
				-121.165402 °	-121.165402 °
DWR ID					
Comment Code					
Inspector Comment					
FS_ID:22873 DS_ID:24677 EP_NO: N/A Repair Type: Non-Urgent Crossing Status: Found UCIP Comments: No permit identified for this crossing. FIELD_STRUCT_DESC: 24-inch polyvinyl chloride (PVC) irrigation pipe through the levee, 5 feet below the crown. Slide gate at the waterside (WS) shoulder. 6-inch steel riser on the WS shoulder. FS Date: 9/17/2013

Concrete turnouts visible off LS toe along road.

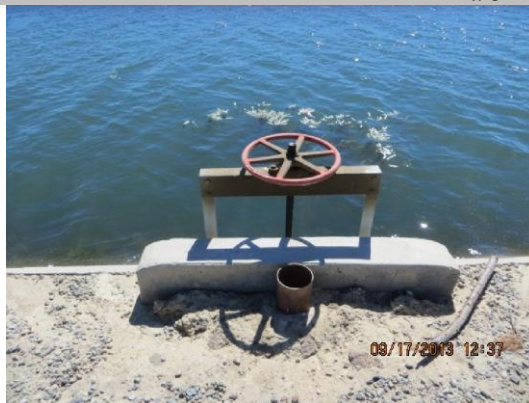
Photo 2 of 2 : UCIP_SP_2018_22873_39037.jpg

LM Start	5.63	Rating **	M	Issue No.	977 (cont)							
LM End	5.63	Issue Type +	En	Location *								
Category	Supplemental		GPS Latitude/Longitude									
			Start	End								
Item	DWR UCIP Field Study		37.630779 °	37.630779 °								
			-121.165402 °	-121.165402 °								
DWR ID												
Comment Code												
Inspector Comment												
FS_ID:22873 DS_ID:24677 EP_NO: N/A Repair Type: Non-Urgent Crossing Status: Found UCIP Comments: No permit identified for this crossing. FIELD_STRUCT_DESC: 24-inch polyvinyl chloride (PVC) irrigation pipe through the levee, 5 feet below the crown. Slide gate at the waterside (WS) shoulder. 6-inch steel riser on the WS shoulder. FS Date: 9/17/2013

Slide gate and vent at concrete headwall on canal at WS shoulder.

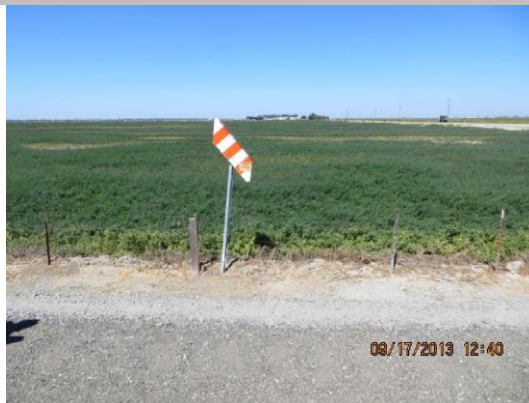
Photo 1 of 2 : UCIP_SP_2018_20745_34961.jpg

LM Start	5.93	Rating **	M	Issue No.	978							
LM End	5.93	Issue Type +	En	Location *								
Category	Supplemental		GPS Latitude/Longitude									
			Start	End								
Item	DWR UCIP Field Study		37.630760 °	37.630760 °								
			-121.159951 °	-121.159951 °								
DWR ID												
Comment Code												
Inspector Comment												
FS_ID:20745 DS_ID:20503 EP_NO: N/A Repair Type: Non-Urgent Crossing Status: Found UCIP Comments: Gasline may not have enough cover. FIELD_STRUCT_DESC: 8-inch gas line of an unknown material through the levee, 1 foot below the crown. Sign on the landside (LS) toe. Pipe visible at canal. [Additional Reference(s): DWR Levee Log, 2005. USACE San Joaquin O&M Manual 4, June 1968, (HLM 5.99)]. FS Date: 9/17/2013

Gasline marker on LS toe.
